# Manhole Inspection Summary

Manhole # S43G\_\_021MH

Insp Date: **6/3/08 9:43 AM**

**Location** Address: **105 narrow ct**

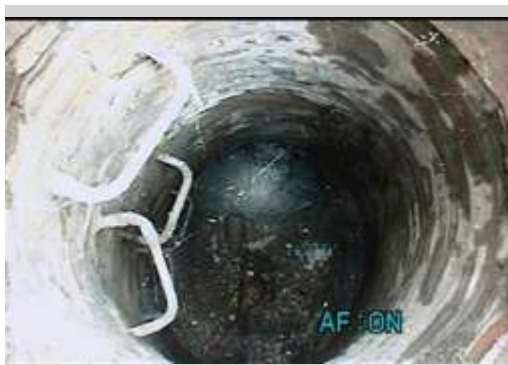
Defect 5

Infiltration: ☐ None ☐ Joint ☐ Cracks ☐ Mortar ☐ Roots ☒ **Wall**

**Steps** Count: **5** Missing: **0** ☒ **Corroded**

**Surcharge** ☒ **Evidence Of Surcharge** Depth: **4** (ft.) ☐ Active Surcharge Present

steps corroded, barrel infiltration,  
surcharge evidence

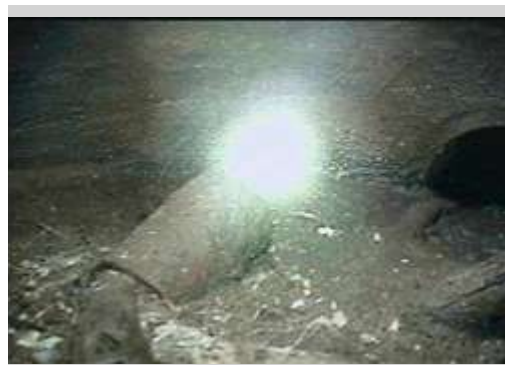
Defect 4

Condition: ☐ Sound ☐ Cracked ☐ Root Intrusion ☐ Deteriorated ☐ Leaks ☒ **Debris**

channel debris and bench debris

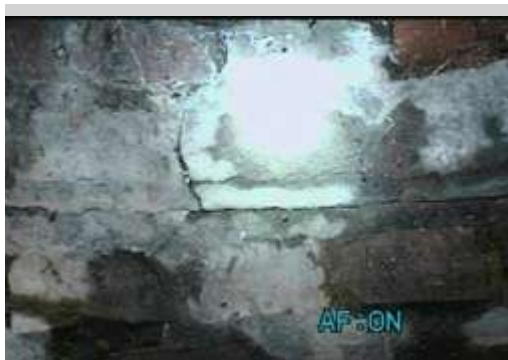
Defect 3

Condition: ☐ Sound ☒ **Cracked** ☐ Root Intrusion ☒ **Loose Brick** ☐ Deteriorated

CHIMNEY\_COND\_CRACKED

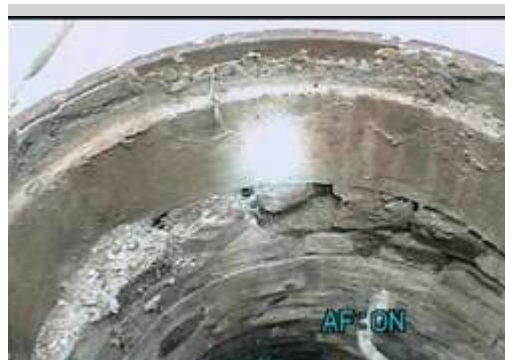
Defect 2

**Frame** Offset: **2** (in.) Condition: ☒ Sound ☐ Cracked ☐ Leaks

Infiltration: ☐ None ☐ Joint ☐ Cracks ☒ **Mortar** ☐ Roots ☐ Wall

FRAME\_OFFSET & loose bricks,  
infiltration

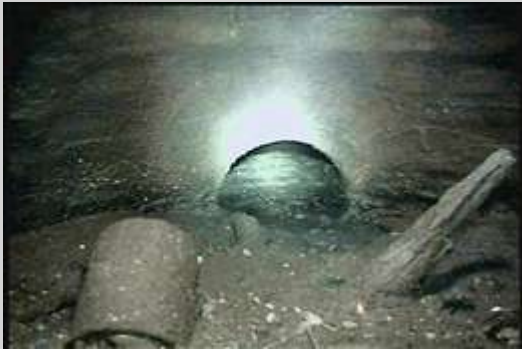
12 O'Clock Outflow

Deposits: ☐ None ☐ Mud ☐ Sludge ☒ **Debris** ☐ Grease

Silt Depth: 4 (in.) Deposits Extent: **Heavy**
